Emerging Concepts in Nondestructive Evaluation

Imaging Composite on F-35

By: Kevin McGushion, CEO
Exel Orbital Systems, Inc.
1448 19th Street
Santa Monica, CA 90404
exelorbital.com
May 17, 2005
Course T304
3:30 PM – 4:45 PM

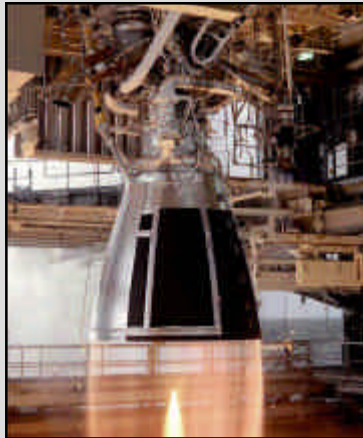
RS-68 Rocket Engine Test

Company: Boeing Rocketdyne (Canoga Park Facility)

Program: RS-68 Rocket Engine

Material: 625 Inconel 1.25" thru 3.50" diameter x .100" wall.

System: EIS-3000

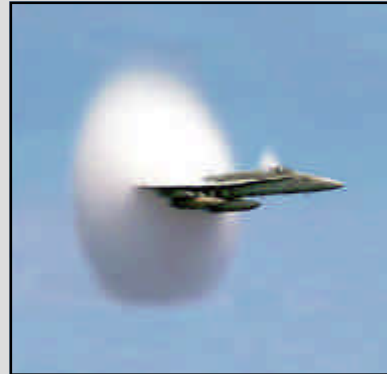
Company: Boeing (St. Louis Facility)

Program: F-18 Fighter

Material: 6-4 Titanium 1/4" thru 1/2" diameter .028 wall.

System: EIS-500

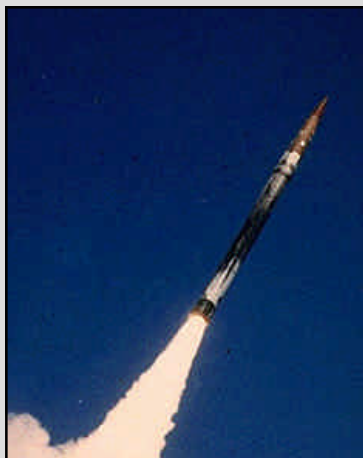
THAAD Missile Test

Company: Boeing Rocketdyne (Desoto Facility)

Program: THAAD (Theater High Altitude Area Defense) Missile

Material: 3-2.5 Titanium, 1/4" thru 5/8" diameter x .028 wall.

System: EIS-500

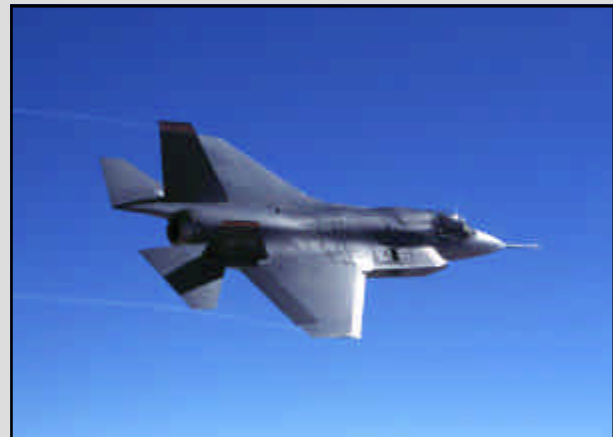
Company: Northrop Grumman (El Segundo Facility)

Program: F-35 Joint Strike Fighter

Material: Graphite Composite Structures

System: Modified system for large surface imaging.

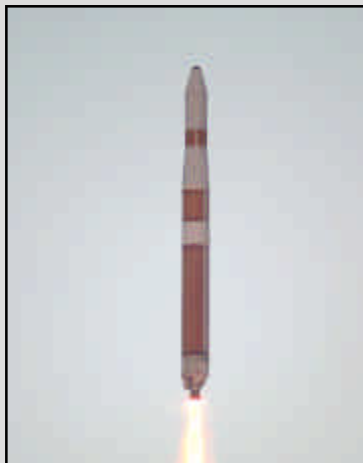
Delta 4 Rocket Launch

Company: Boeing (Huntington Beach Facility)

Program: Delta 4 Rocket

Material: 625 Inconel 1/4" thru 1/2" diameter.

System: EIS-500

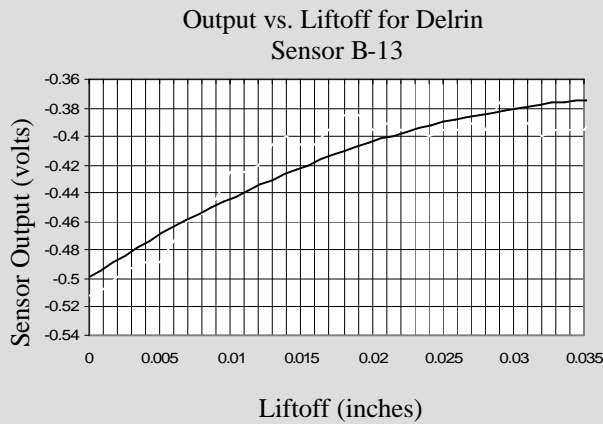
Output vs. Liftoff for Delrin

The first and most important observation is that there is an output change relative to liftoff and even when liftoff is '0'. This directly implies that the presence of both types on insulators with high electrical resistivity affect the sensor. In a more detailed observation the signal output for a given liftoff for each material is different. This means that as the sensor is passed over a sample comprised of 2 different polymers, (in this case Delrin and LDPE) an output signal change can be

expected. For instance at '0' liftoff Delrin has an output of -0.500 volts and LDPE has an output of -0.460 volts for an overall visible difference of $.040$ volts. A very discernable difference for the Exel Imaging System.

According to the liftoff tests on the previous page there is a distinct difference between air and Delrin.

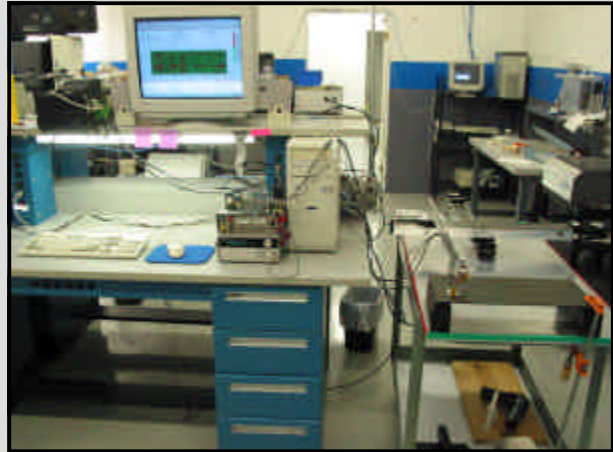
Prototype Imaging Systems for Composite

Below are photographs of Exel's prototype imaging system for scanning composite. The system is designed to scan a 24" x 24" area in order to accommodate medium size composite panels. The system is designed to test a number of variables such as data density and travel speed. Data collection densities as high as 1 point every $.001$ inches and as low as 1 point every $.10$ inches have been tested to obtain the optimum density to reveal flaws of a critical size for composite. That size is determined to be $.250$ inches.

The prototype system was operated at maximum speed or about 225 in/ minute or 1/4 of a mile per hour. However tests indicate that speed in excess of 100 times faster or greater than 25 mph are possible and the only real limitation is safety based.

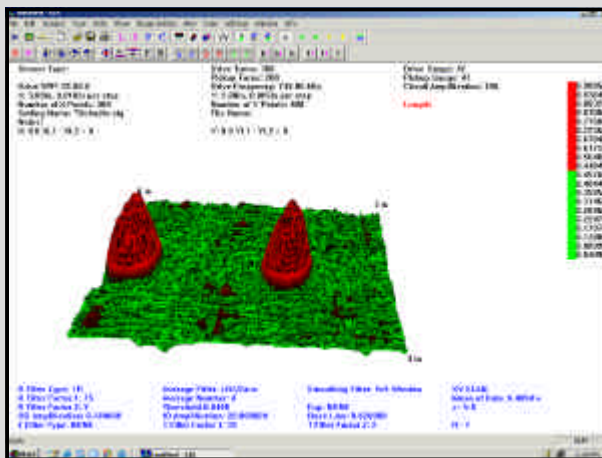
Image of LDPE Plugs in Delrin

To test the ability of the imaging system to differentiate between Delrin and LDPE, two holes, each 1/2" in diameter were drilled in a Delrin block. Two 1/2" diameter plugs of LDPE were pressed into the holes and a fly cut taken, with a milling machine on the face of the sample to ensure that there was not a height difference between the 2 materials. This sample is shown below. The image below shows the relative

ease with which the imaging system can detect the LDPE plugs in the Delrin background.

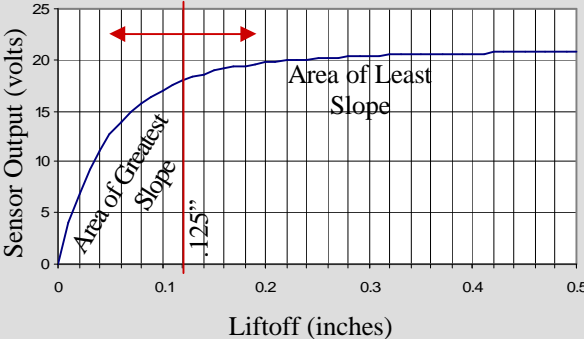
Graph of Slope

between '0' liftoff or depth and .125" lie in the area of greatest slope. In this area slight differences in size or depth of an anomaly have a large affect on the output signal. Beyond .125" anomalies are still visible however, the differences related to depth or size are comparatively small. On the Disk Depth Chart it can be

Output vs. Liftoff for Graphite Composite
Sensor B-13

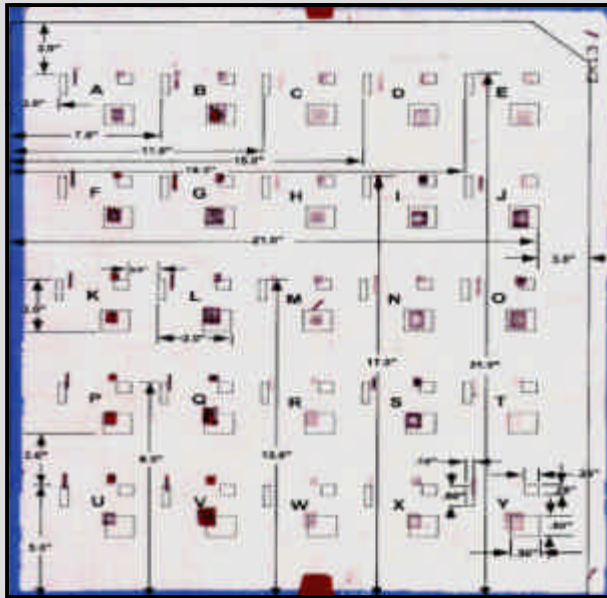
AUS Image of Sample EX13 Superimposed on FOD Drawing

Below is a sample created to evaluate the detectability of various types of backing material or FOD that can be expected in the processing of composite. In this case the composite is MMS 5024. This sample is an 18 ply lay-up that is .133" in overall thickness. While not all of the flaws were visible the first row of flaws had very good correlation as can be seen in the detail views to the right. The table to the right defines the type of FOD tested as well as the respective thickness.
